Surveys of Abandoned Vessels:

Guam and CNMI

**SURVEYS OF ABANDONED VESSELS:
GUAM AND THE COMMONWEALTH OF THE NORTHERN MARIANA ISLANDS**

October 2003

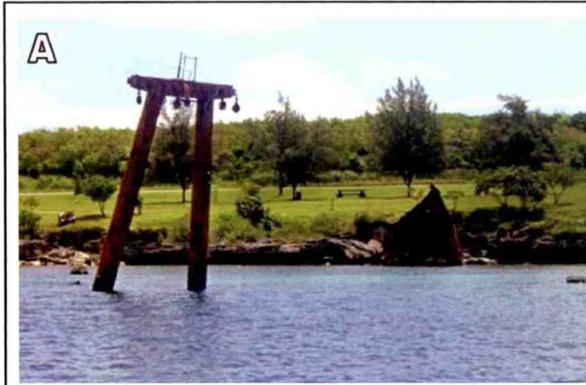
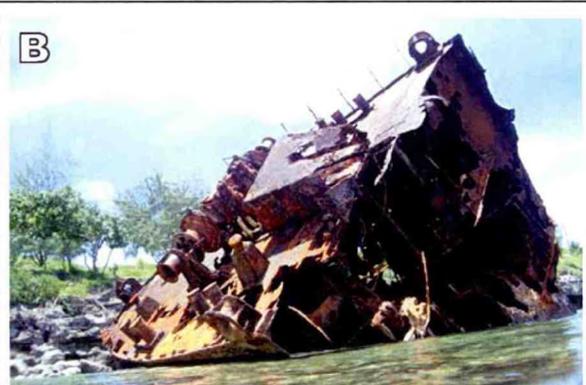
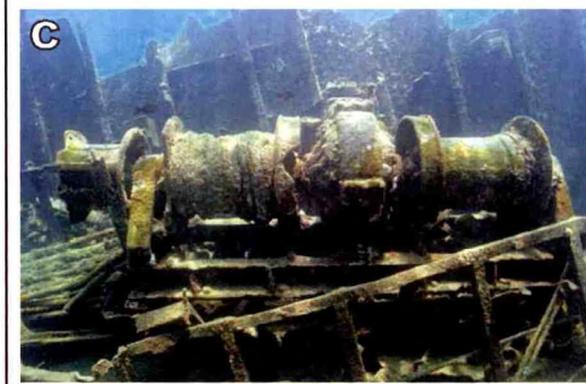
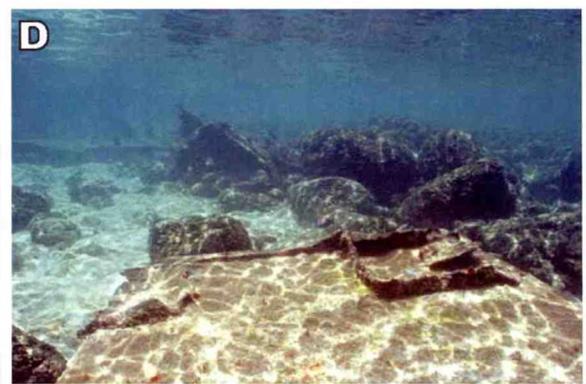
PLATE 5. *Sun Long No. 8*, Tinian Harbor, Tinian.

Environmental Characterization: The primary habitat type is coral reef/hardbottom. There is some rubble surrounding the vessel with live coral ranging from <10% to ~10-30% cover. The reef is very close to the bow (~20% live cover) but is ~45 ft off of the port and starboard sides.

Comparison to Other Vessels/Removal Considerations: This is one of two sites that had extensive debris fields over a range of depths. *Sun Long No. 8* is one of the largest vessels surveyed at 325 ft.

- A. Kingpost and large piece of debris on shore.
- B. View of large piece of debris on riprap shoreline.
- C. View of dense debris.
- D. Small portion of debris field and sand and gravel substrate with coral rubble.
- E. Anchor among the debris atop sand and gravel.

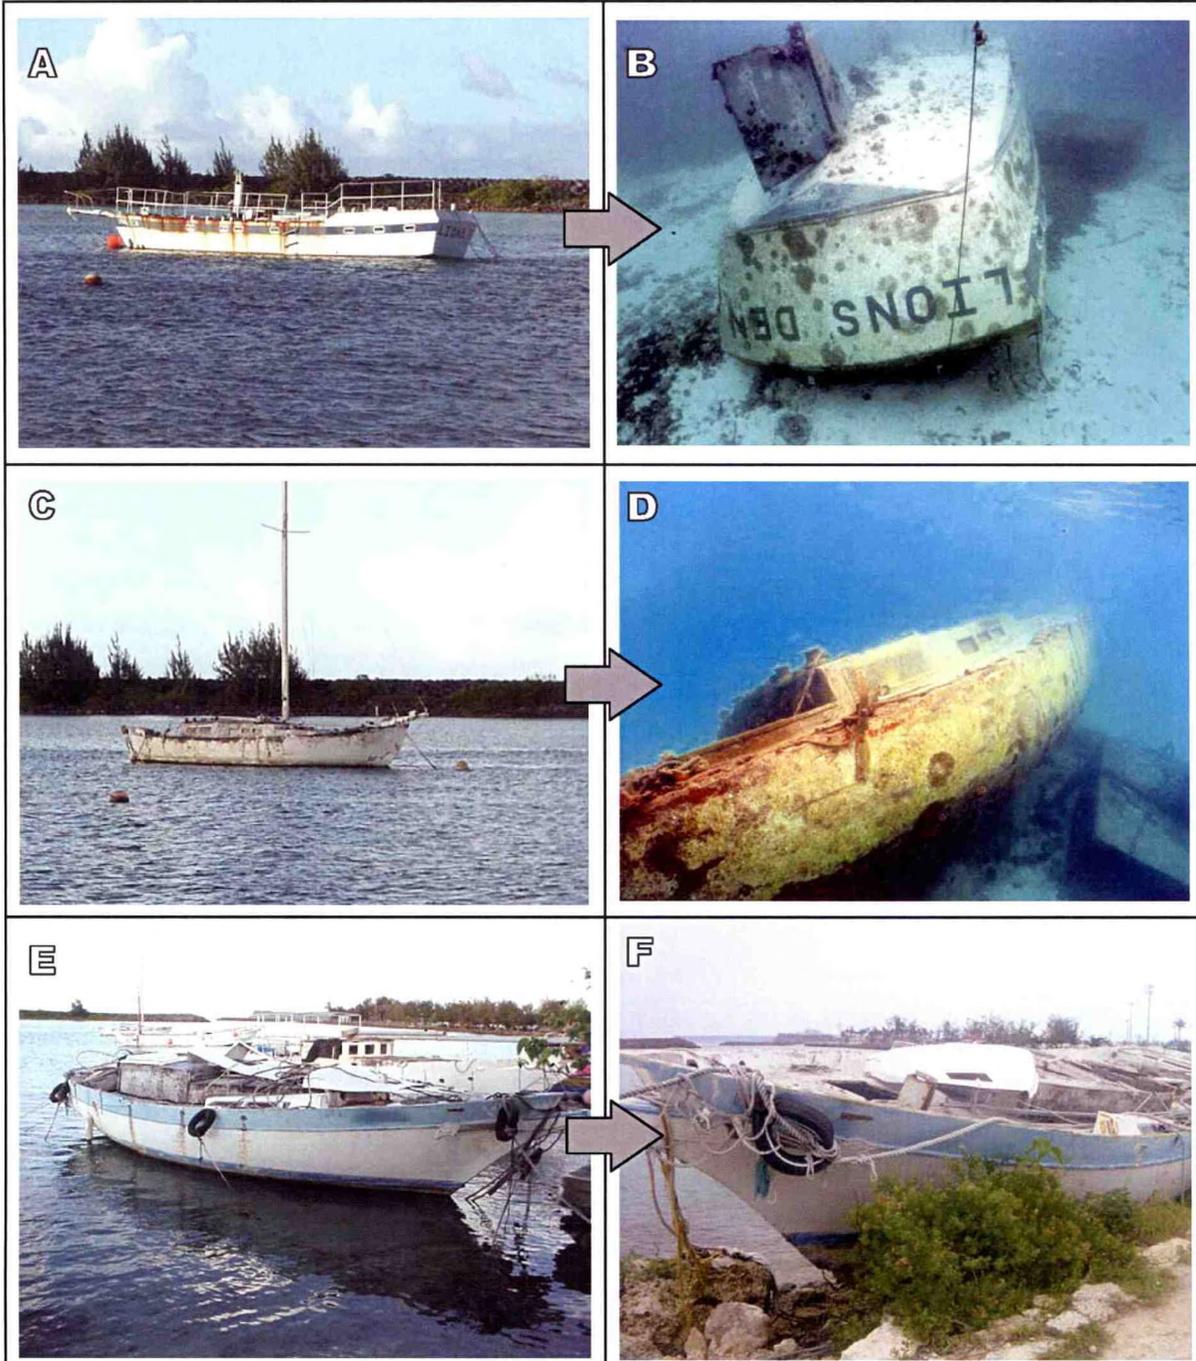
PLATE 12. (See Below) Formerly derelict, now grounded/sunken vessels in Agana Boat Basin, Guam.

Vessel Information: The vessels pictured below were described in Plate 10 as a cluster of sunken/grounded vessels observed during the 2003 surveys. Photos A, C, and E were taken prior to Supertyphoon Pongsona in 2002. The vessels were derelict and identified as risks for grounding/sinking at that time. Photos B, D, and F were taken following the storm during the 2003 surveys.

A& B. *Lion's Den*, Incident ID: 1901.

E&F. *Ciao*, Incident ID: 2541 (foreground) and Unk2539 (background). See Plate 10, photo D for present condition of Unk2539.
